MEMO TO FILE

The following information,	Photos	, has been
separated from the rest of the		
site, Schree-Morehead Ch	OMID # TXDOO73	334659 , because
the material could not be sto	red at the Federal	Records Center due
to certain storage restriction	ns.

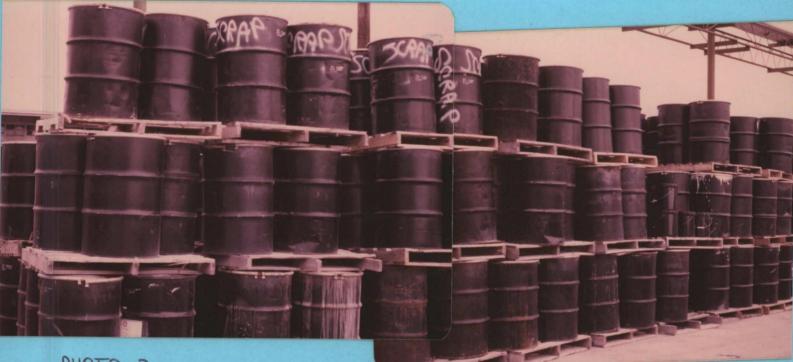
PHOTO 1-2

comments: Drum Storage on north Side of plant near railroad tracks. Note that drums are on pallets for easy movement.

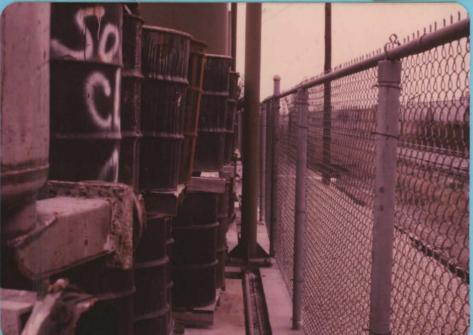
PHOTO 3

side of property. Note drainage conduits in cement slab.

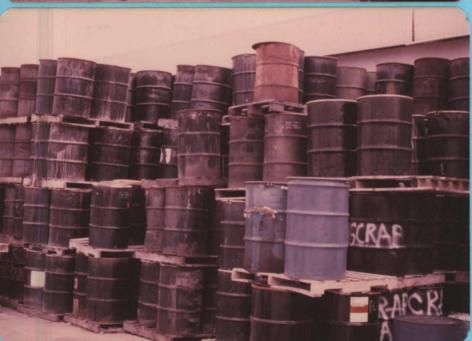
Comments: Drum storage on

West side of plant property

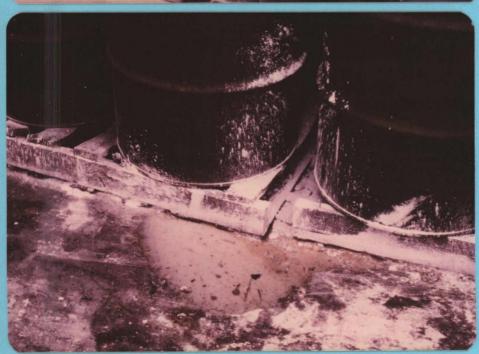
PHOTO 6
Photographer / Witness

Comments: Leakage from drum.

Powdered calcium carbonate

(Caloz) is spread on spill to help

congeal the material, which

is then scraped up.

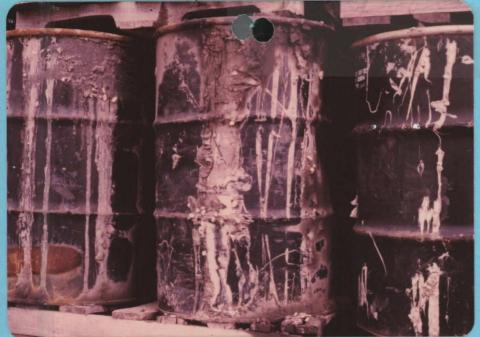
F o 7
Photographer / Witness
Barry Nash
Date / Time / Direction
2-27-81/1045/ CLOSEUP
Comments: Leakage from drums.
As material comes in contact
with air, solvent evaporates and
the material turns to a
rubbery consistency. Spills do
rubbery consistency. Spills do not travel far.
PHOTO 8 Photographer / Witness
Barry Nach
Date / Time / Direction
2-27-81/1055/ NNE
comments: Drum storage on
west side of plant
property. Fenced area
to left is Koppers Paints.
Photographer / Witness
Date / Time / Direction
